description of application

Inspection of plastic quart sized motor oil bottles for streak defects. The goal of this application is to image the bottles clearly to determine if there are any streak defects.

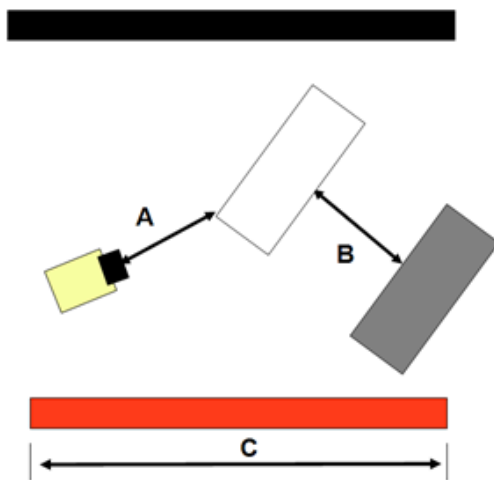
Illumination: **L300-850-W** [300mm Linear Light 850nm IR - "Connect-A-Light"]

Light @ same angle as bottle

Filter: **BP850**

(A) Lens Working Distance: 12"

(B) Light Working Distance: 7"

(C) Horizontal Field of View: 8"

Top view of setup plastic bottle surface inspection

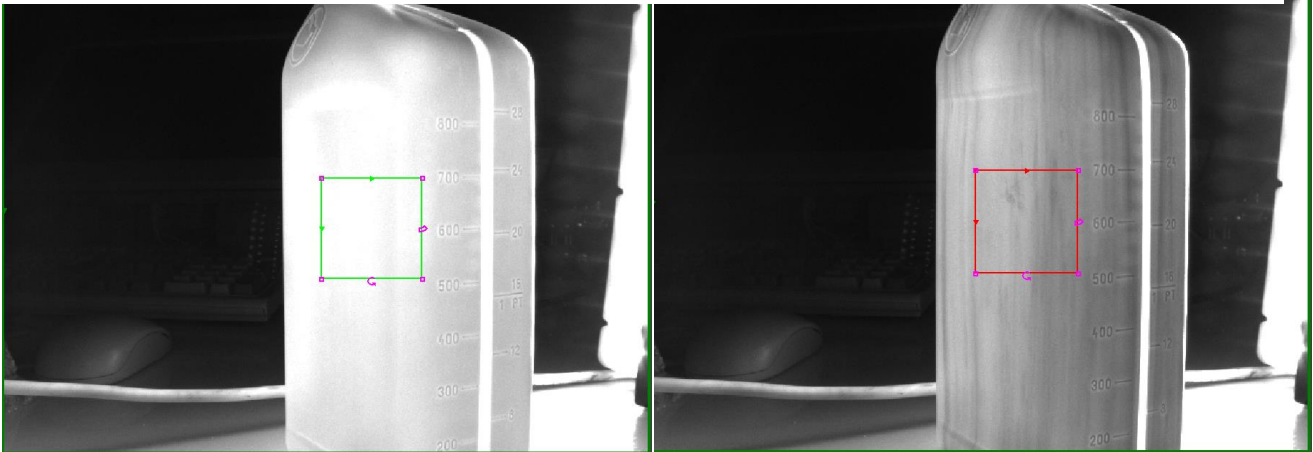
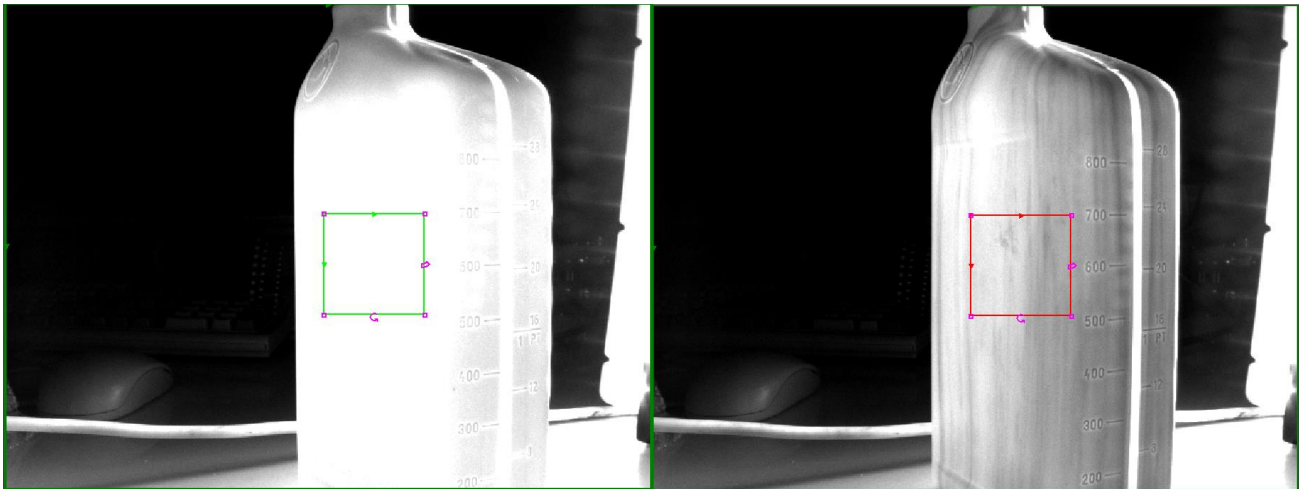
Above: Left - Raw image of a good bottle. Right - Raw image of a streaked bottle.
Below: Filtered images of the bottles above.

Infrared lighting lends itself to be very useful when looking at different plastic applications. By lighting the bottle with an intense IR light the streaks show up. A good bottle appears very white almost washed out as a streaked bottle is much darker. The trick is to illuminate the bottle without creating too much hot spotting. In this application a linear light was used with good results. Increased results could be obtained by utilizing a high powered back light to create more even lighting.
